ILLINOIS ENVIRONMENTAL PROTECTION AGENCY MEMORANDUM

DATE: 3 November 2010

SUBJECT: LPC #1198010003 – Madison County

Hartford/Chemetco

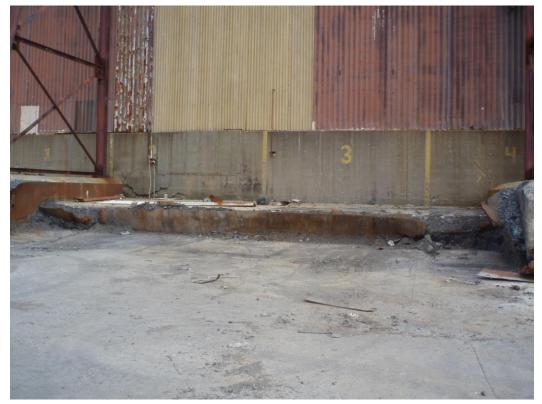
Piles of pot slag were removed from the area on the west side of the Foundry Building as shown in the attached photo #001. The piles were consolidated inside the building with additional pot slag piles for shipment off-site to Arubis Corporation in Belgium (see attached photos #002 & #003). The pot slag was in the process of being loaded into containers at the time of this site visit. Mr. Garcia explained that 10 containers have already been filled with pot slag. Each container holds approximately 43,000 pounds. Mr. Garcia explained that the 60 drums of metal fines inside the Foundry Building will be combined with the pot slag piles for shipment to Arubis.

Date: 28 October 2010
Time: 1:39 pm
Direction: E
Photo by: M. Cozadd
Exposure #: 001
Comments: Piles of pot
slag removed from the
area in front of the
Foundry Building.

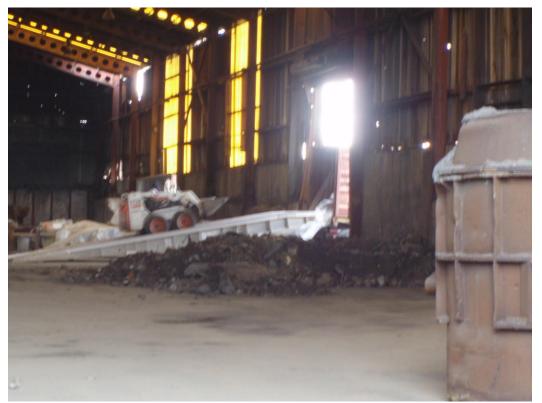
Date: 28 October 2010
Time: 1:41 pm
Direction: SW
Photo by: M. Cozadd
Exposure #: 003
Comments: Piles of pot
slag being loaded from
inside Foundry Building
for sale to Arubis
Corporation.

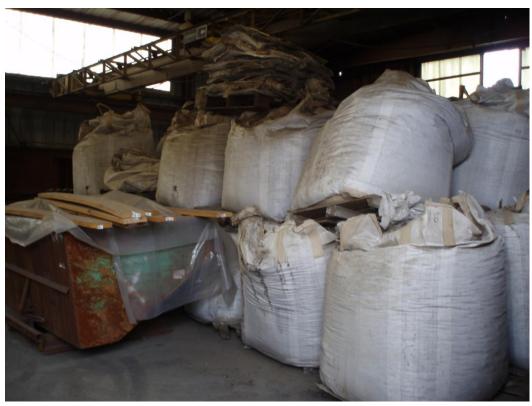
The super sacs staged inside the receiving building are shown in the attached photo #004. Mr. Garcia explained that the Estate is in the process of trying to sell this material. The 13 waste drums near the Receiving Building have been removed and are in the process of being lab packed for shipment off-site along with the Tank House waste streams. The area near the Receiving Building where the drums were located previously is illustrated in the attached photos #005 and #006.

Date: 28 October 2010 Time: 1:44 pm Direction: NW Photo by: M. Cozadd Exposure #: 004 Comments: Super sacs

inside Receiving

Building.

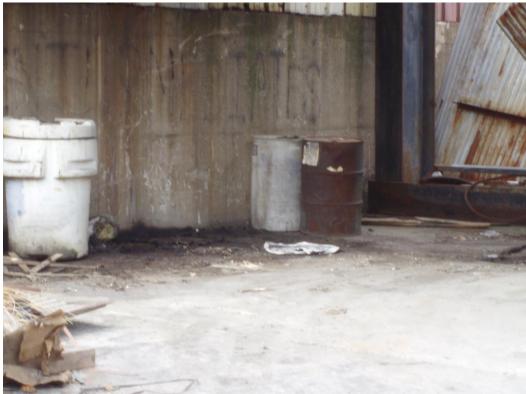
Date: 28 October 2010 Time: 1:45 pm Direction: NW Photo by: M. Cozadd Exposure #: 005 Comments: Waste drums removed from area near Receiving Building.

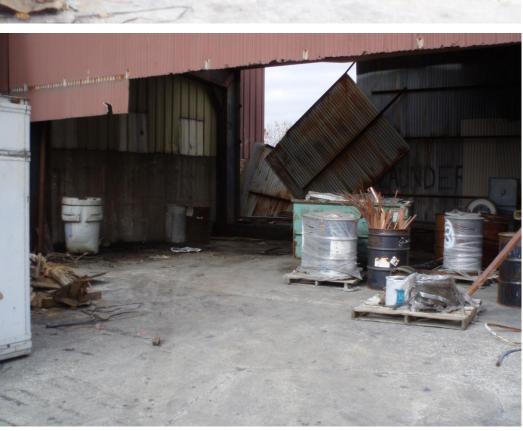
Date: 28 October 2010 Time: 1:45 pm Direction: NW Photo by: M. Cozadd Exposure #: 006 Comments: Waste drums removed from area near Receiving Building.

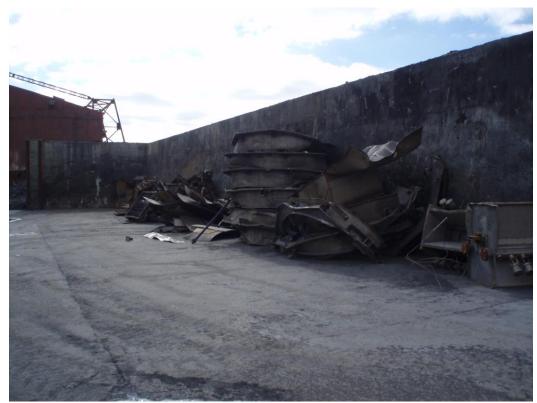
Piles of scrap metal are shown in the attached photos #007, #008, and #009. In addition, a scrap metal pile near the AAF area that will be relocated to the Dome Building is illustrated in the attached photo #018. A wet decontamination procedure using sand hydroblasting is being evaluated for use on the scrap metal.

Date: 28 October 2010
Time: 1:49 pm
Direction: SW
Photo by: M. Cozadd
Exposure #: 007
Comments: Scrap metal
staged inside Dome

Building for decontamination.

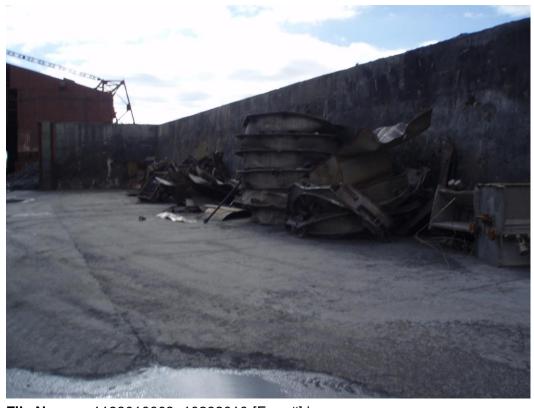
Date: 28 October 2010
Time: 1:49 pm
Direction: SW
Photo by: M. Cozadd
Exposure #: 008
Comments: Scrap
metal staged inside
Dome Building for
decontamination.

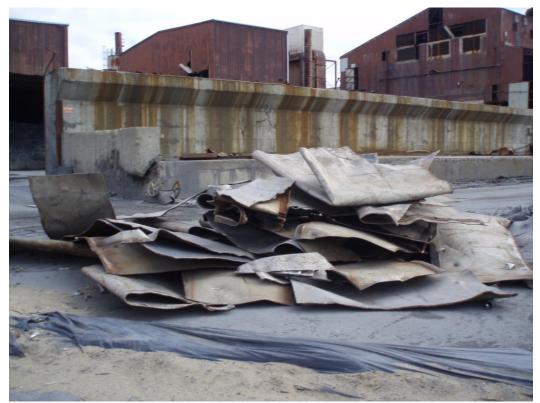
Date: 28 October 2010
Time: 1:52 pm
Direction: SE
Photo by: M. Cozadd
Exposure #: 009
Comments: Scrap metal
staged just outside
Dome Building for

decontamination.

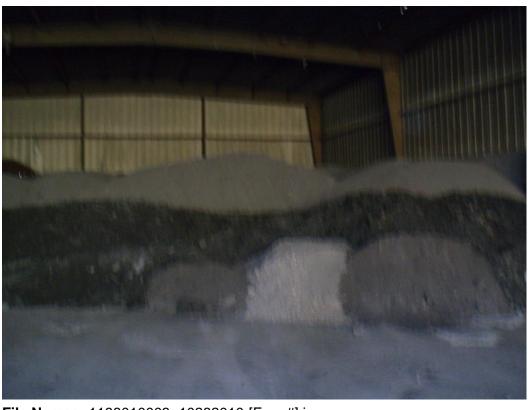
The screened material in the Fines Building is shown in the attached photos #010 through #012. A small amount of debris was observed in the piles of screened material as illustrated in the attached photos #013 and #014. Mr. Murray agreed to have his workers remove the debris by the end of the day. I recommended that the piles in the Fines Building be inspected daily for debris that may accidentally be placed in the piles.

Date: 28 October 2010
Time: 1:57 pm
Direction: NW
Photo by: M. Cozadd
Exposure #: 010
Comments: Screened
material in Fines
Building.

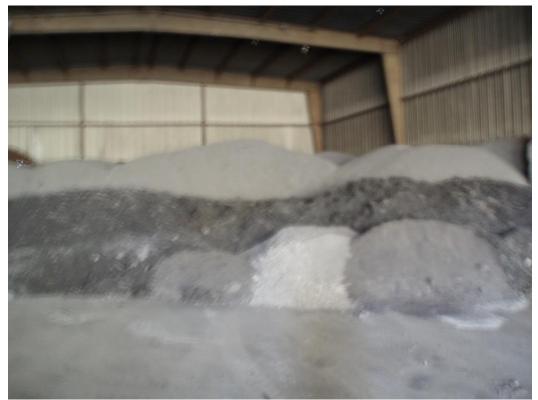
Date: 28 October 2010
Time: 1:57 pm
Direction: NW
Photo by: M. Cozadd
Exposure #: 011
Comments: Screened
material in Fines
Building.

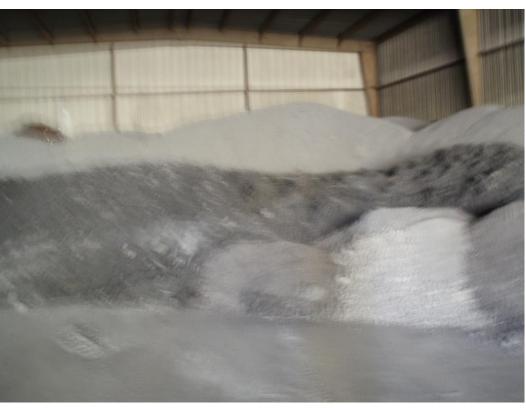
Date: 28 October 2010
Time: 1:57 pm
Direction: NW
Photo by: M. Cozadd
Exposure #: 012
Comments: Screened
material in Fines
Building.

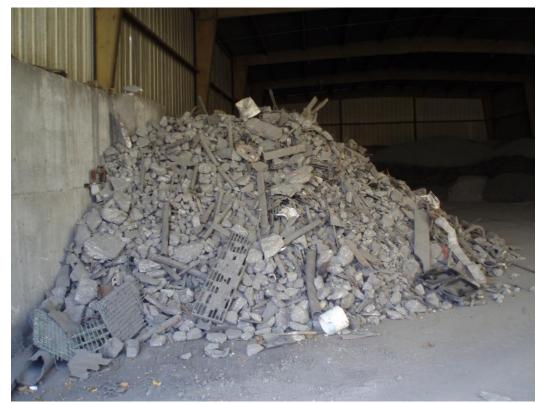
The waste pile of broken concrete, damaged dimensional lumber, and other miscellaneous wastes is shown in the attached photo #015. This waste pile will be manifested off-site as hazardous waste.

Date: 28 October 2010
Time: 1:58 pm
Direction: NW
Photo by: M. Cozadd
Exposure #: 015
Comments: Segregated
broken concrete,
damaged dimensional
lumber, and other
miscellaneous wastes
from screening
operations in Fines
Building.

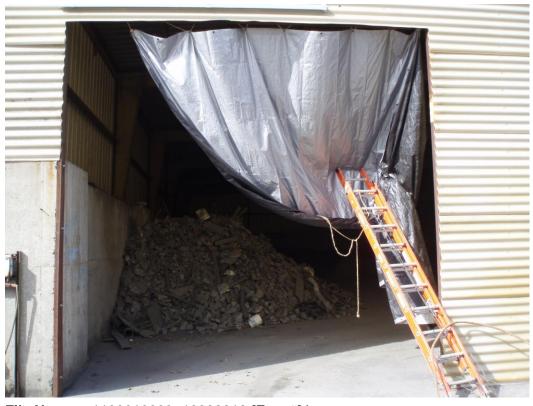
The tarp has been installed on opening to the Fines Building (see attached photo #016). The tarp was propped open with a ladder. I recommended that the tarp be closed at the end of each day.

Date: 28 October 2010
Time: 1:59 pm
Direction: NW
Photo by: M. Cozadd
Exposure #: 016
Comments: Tarp at
entrance to Fines

Building.

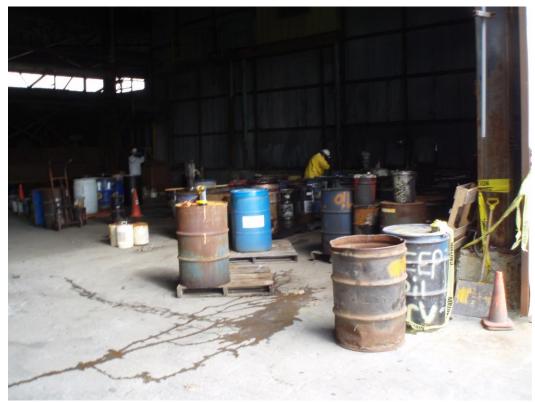
Photo by: M. Cozadd Exposure #: 017

The attached photo #017 shows the crew lab packing the waste streams inside the Tank House at the time of this site visit.

Comments: Lab packing & consolidation of waste materials in Tank House for shipment off-site.

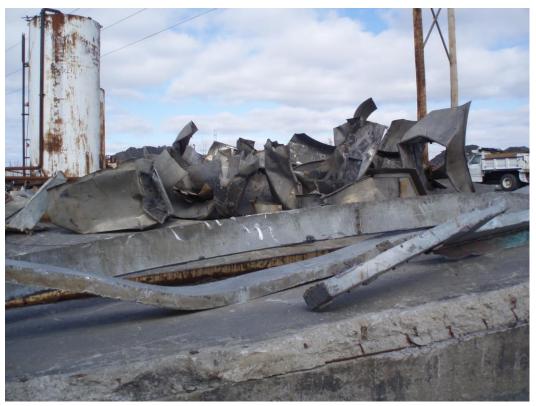
Photo by: M. Cozadd Exposure #: 018 Comments: Scrap metal near AAF area to be moved to Dome

Building for decontamination.

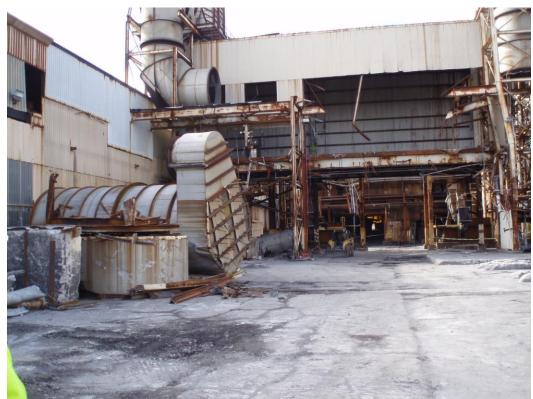
AIS is continuing demolition in the AAF area (see attached photos #019 and #020).

Photo by: M. Cozadd Exposure #: 019 Comments: Demolition phase of AAF area.

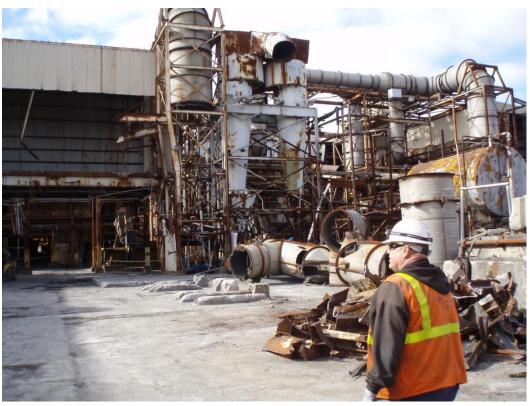
Date: 28 October 2010 Time: 2:12 pm Direction: NW Photo by: M. Cozadd Exposure #: 020

Comments: Demolition phase of AAF area.
